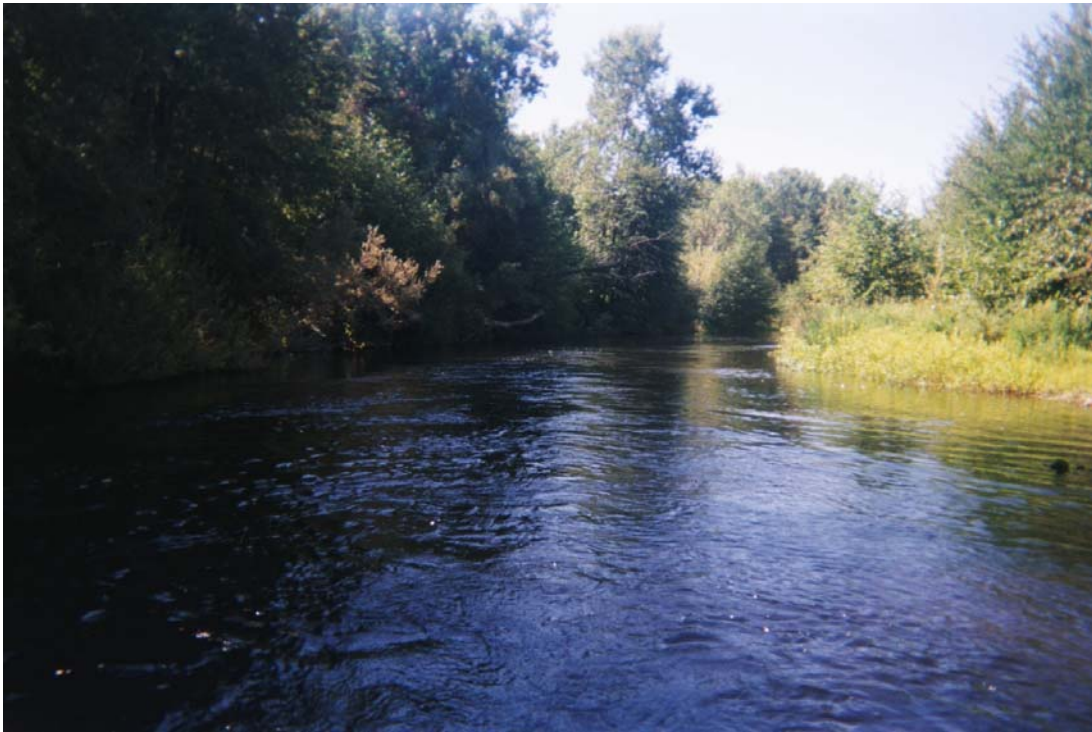
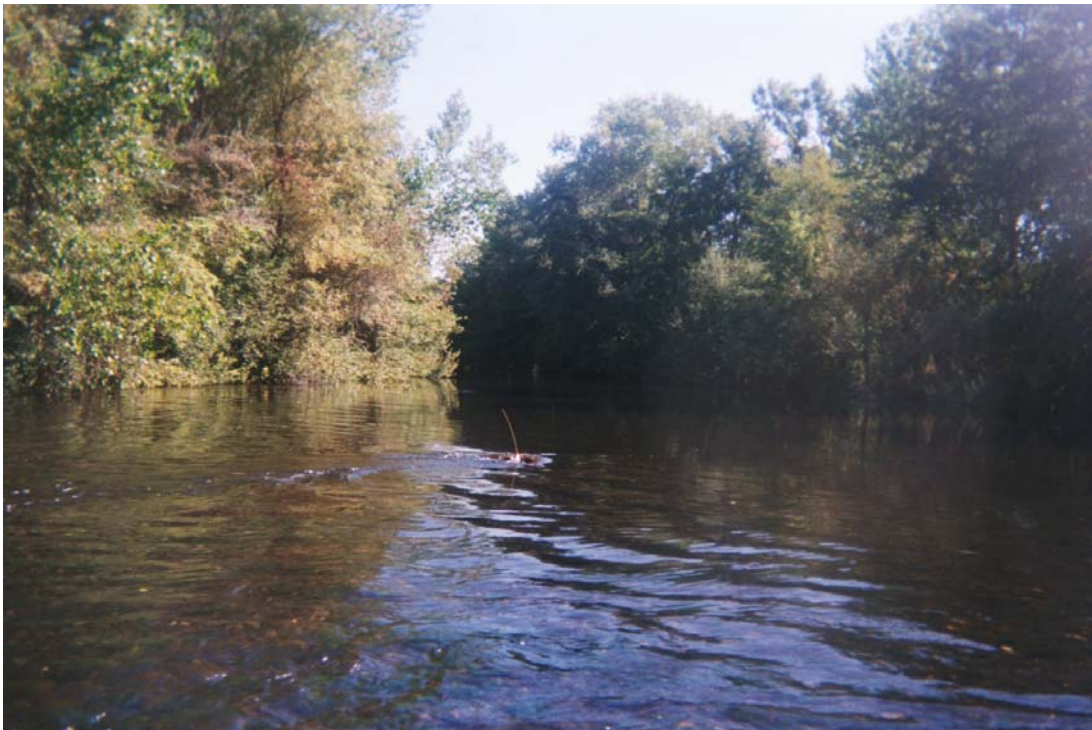
Figure 7: Ukiah Reach, Segment U3. This segment has a well-developed riparian cover, and contained 1% riffle and 99% flatwater habitats. No steelhead were observed.

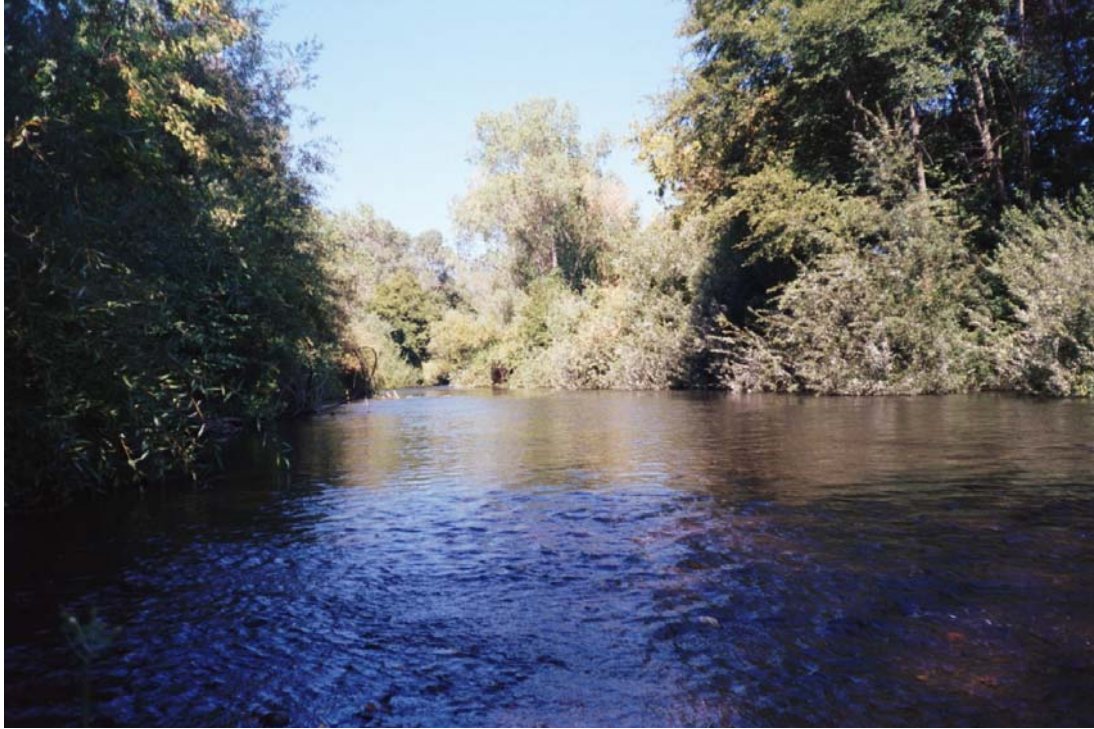
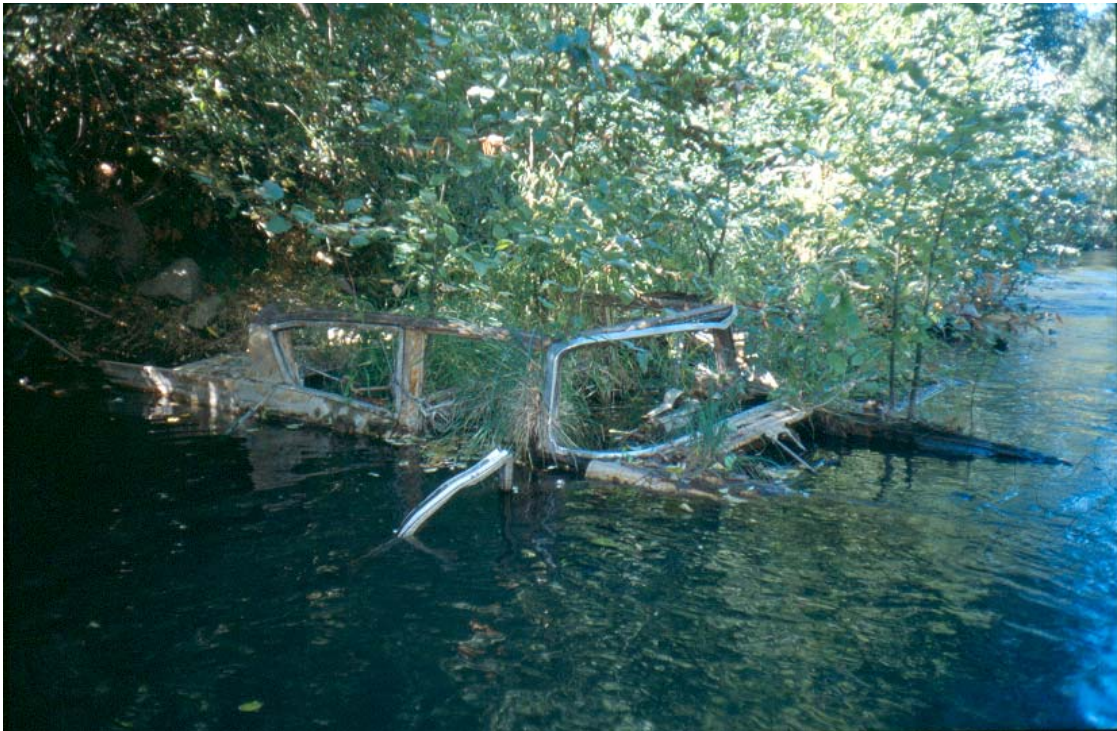
Figure 8: Ukiah Reach, Segment U4. This segment contained primarily flatwater habitat with well-developed riparian vegetation (top). Also, typical in this reach are past erosion control attempts that included lining the banks with automobile bodies (bottom).

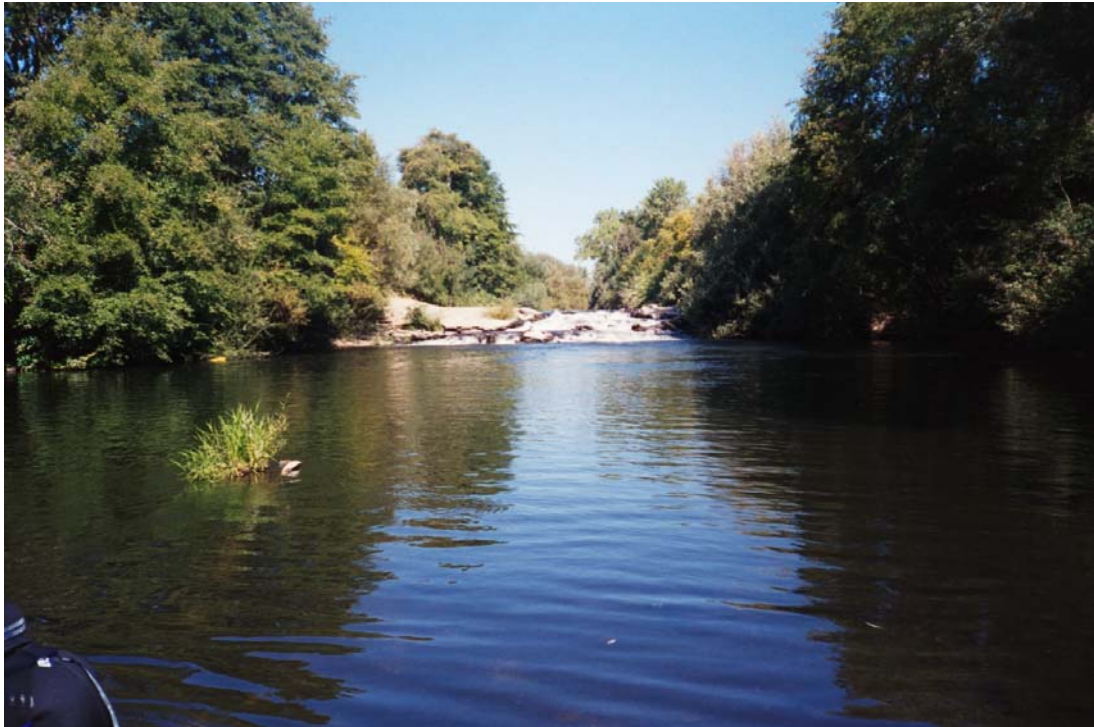
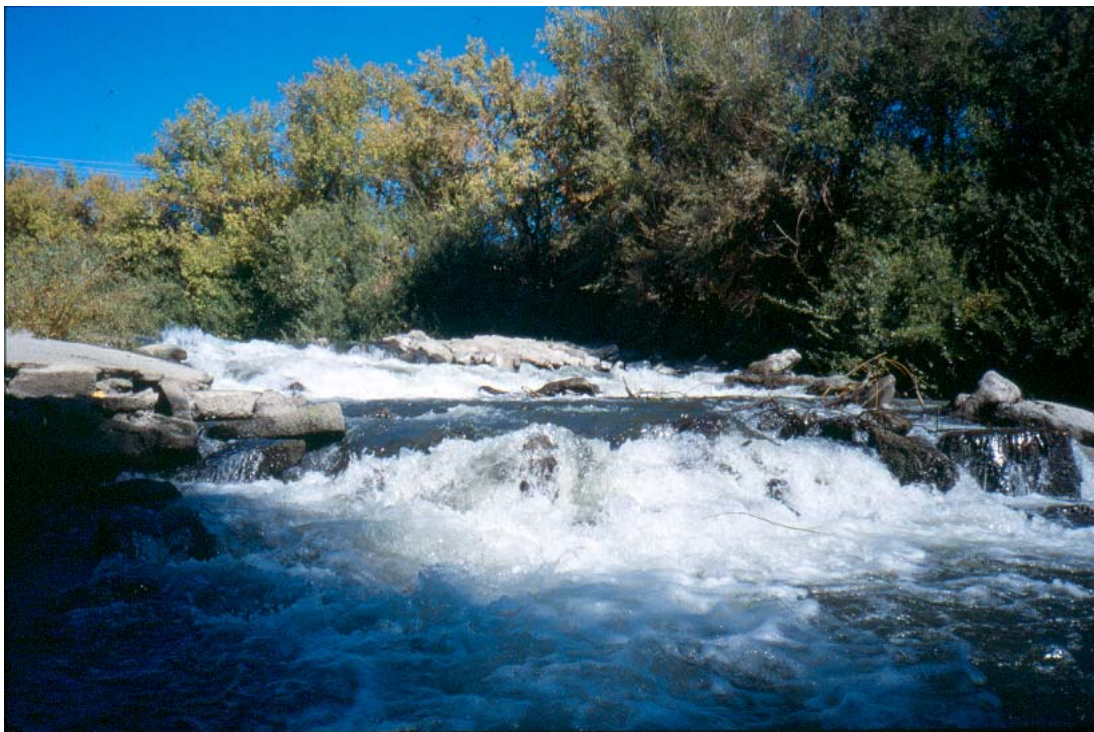
Figure 9: Ukiah Reach, Segment U4, Norgard Dam. This segment contained artificial cascade and riffle habitats at the Norgard Dam and downstream weir. A deep pool is located below the dam (top). Most of the 161 observed steelhead were found in the artificial cascade habitat at the dam (bottom).

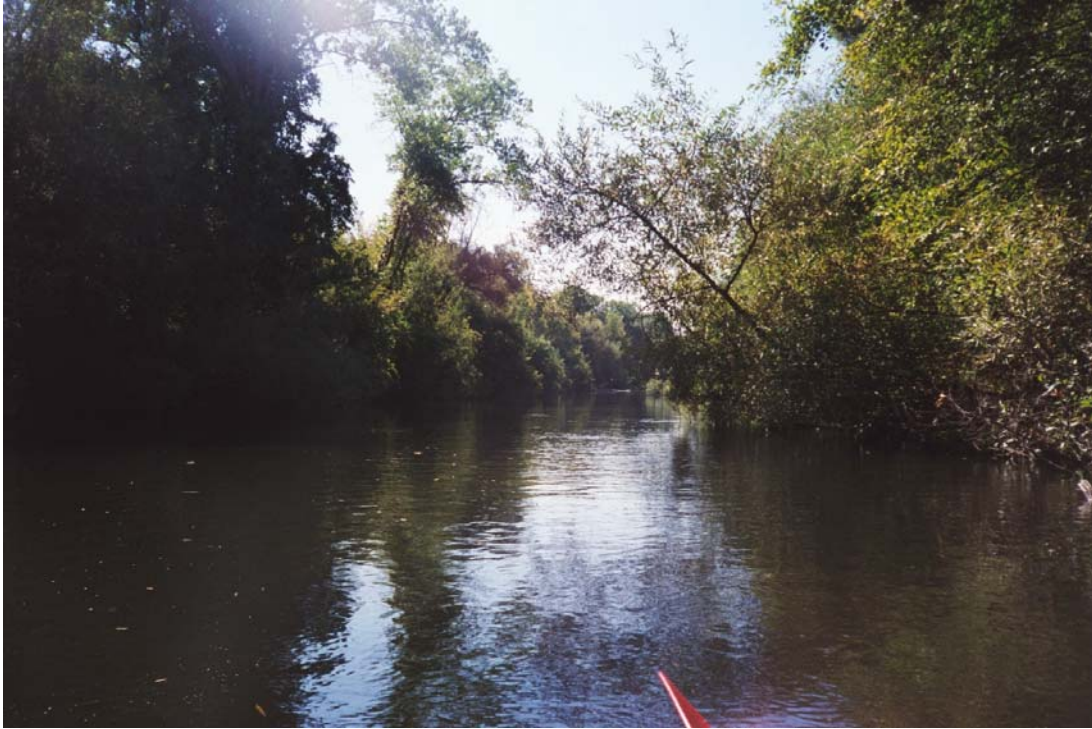
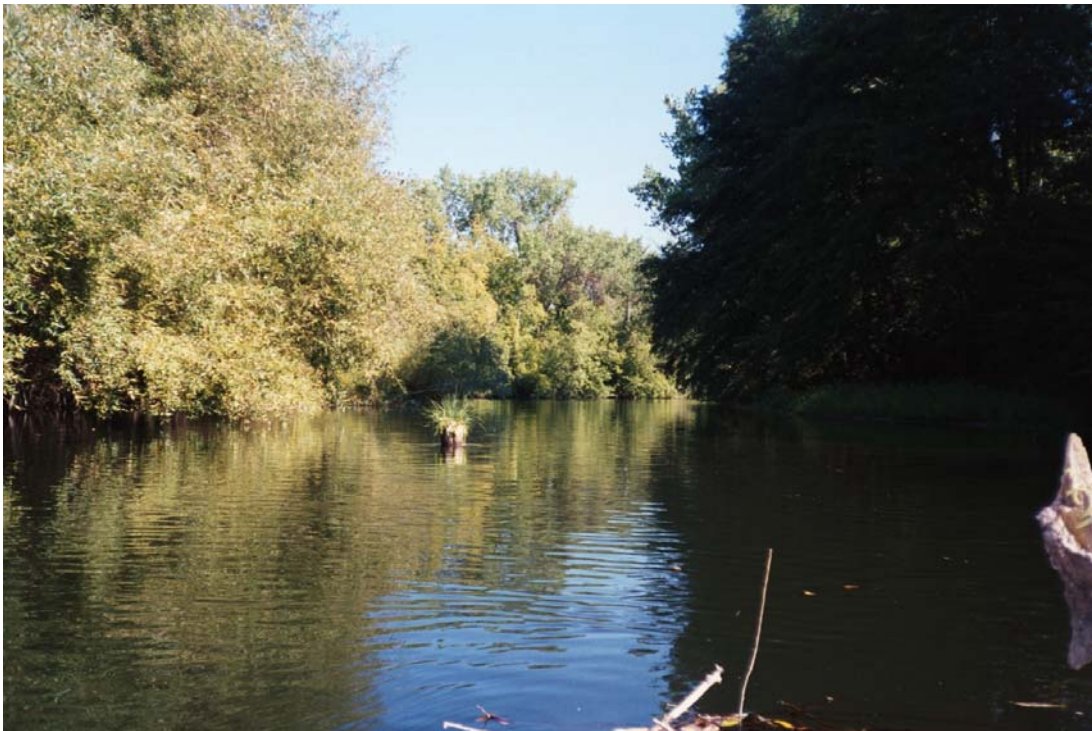
Figure 10: Ukiah Reach, Segment U5. This segment contained primarily flatwater habitat with well-developed riparian vegetation. No steelhead were observed.

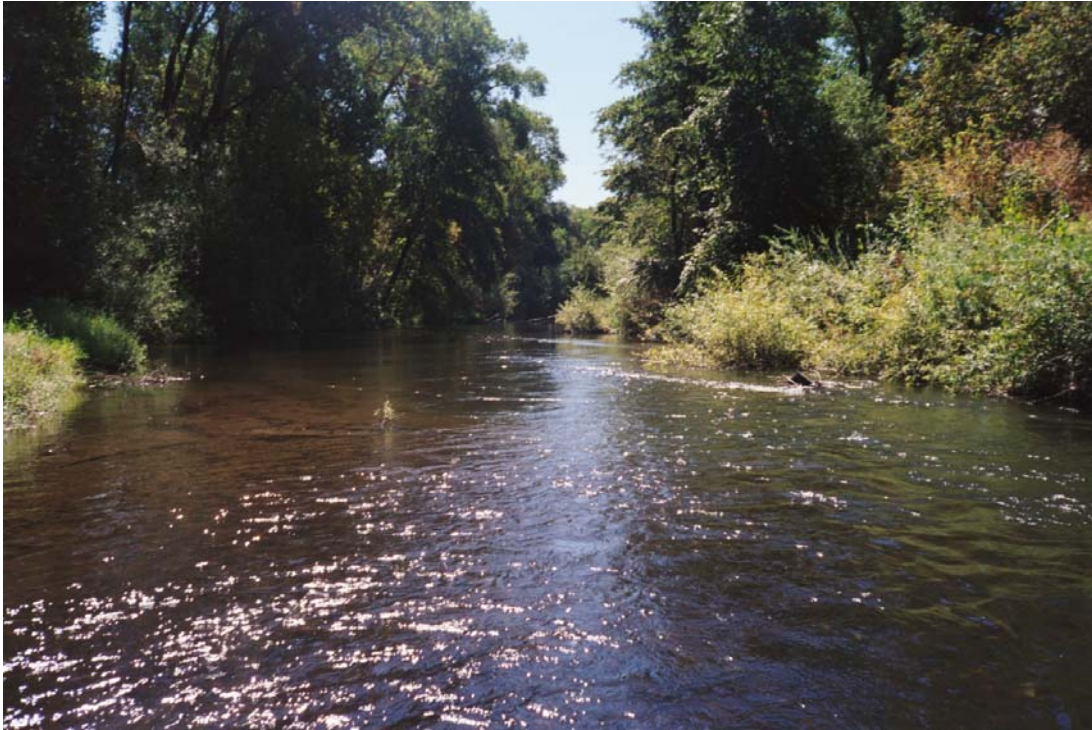
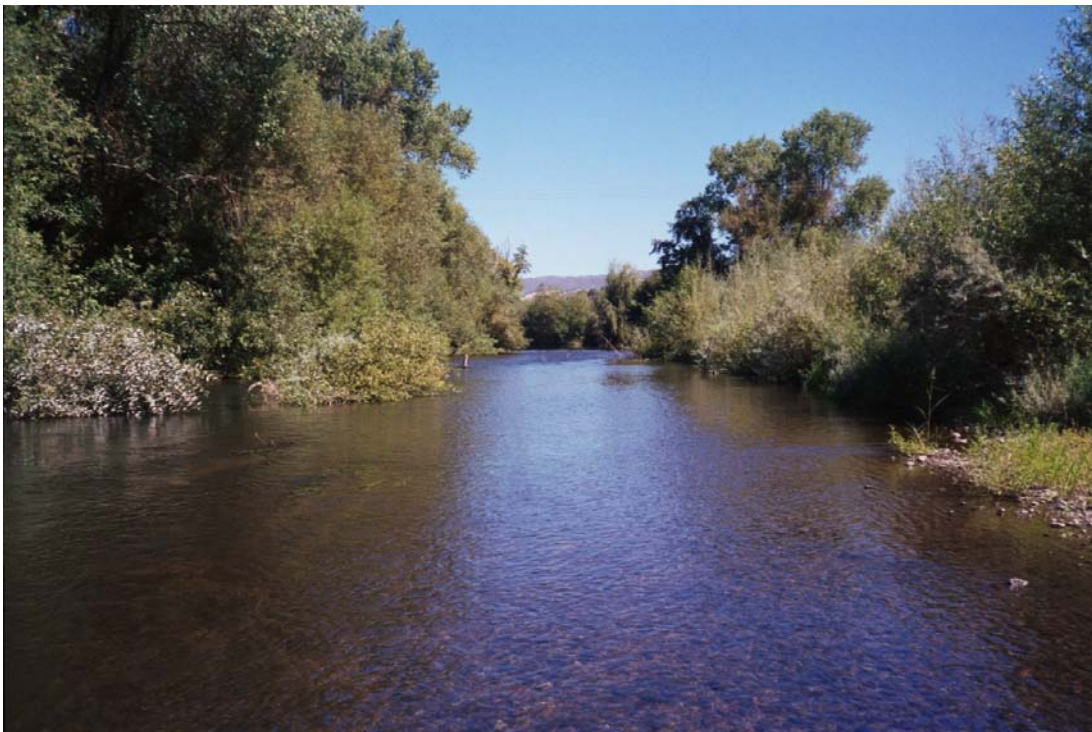
Figure 11: Ukiah Reach, Segment U6. This segment contained 97% flatwater, 1% riffle, and 2% deep pool habitats. No steelhead were observed.
